MEMORANDUM FOR: CAPT Greg Stump, Commanding Officer, Sector San Francisco.

FROM: Robert Schwemmer,
 Regional West Coast Maritime Heritage Coordinator
 Lisa Symons,
 Damage Assessment and Resource Protection Coordinator
 James Delgado,
 Director of Maritime Heritage

SUBJECT: Sonar Data Site Characterization MV *Fernstream*

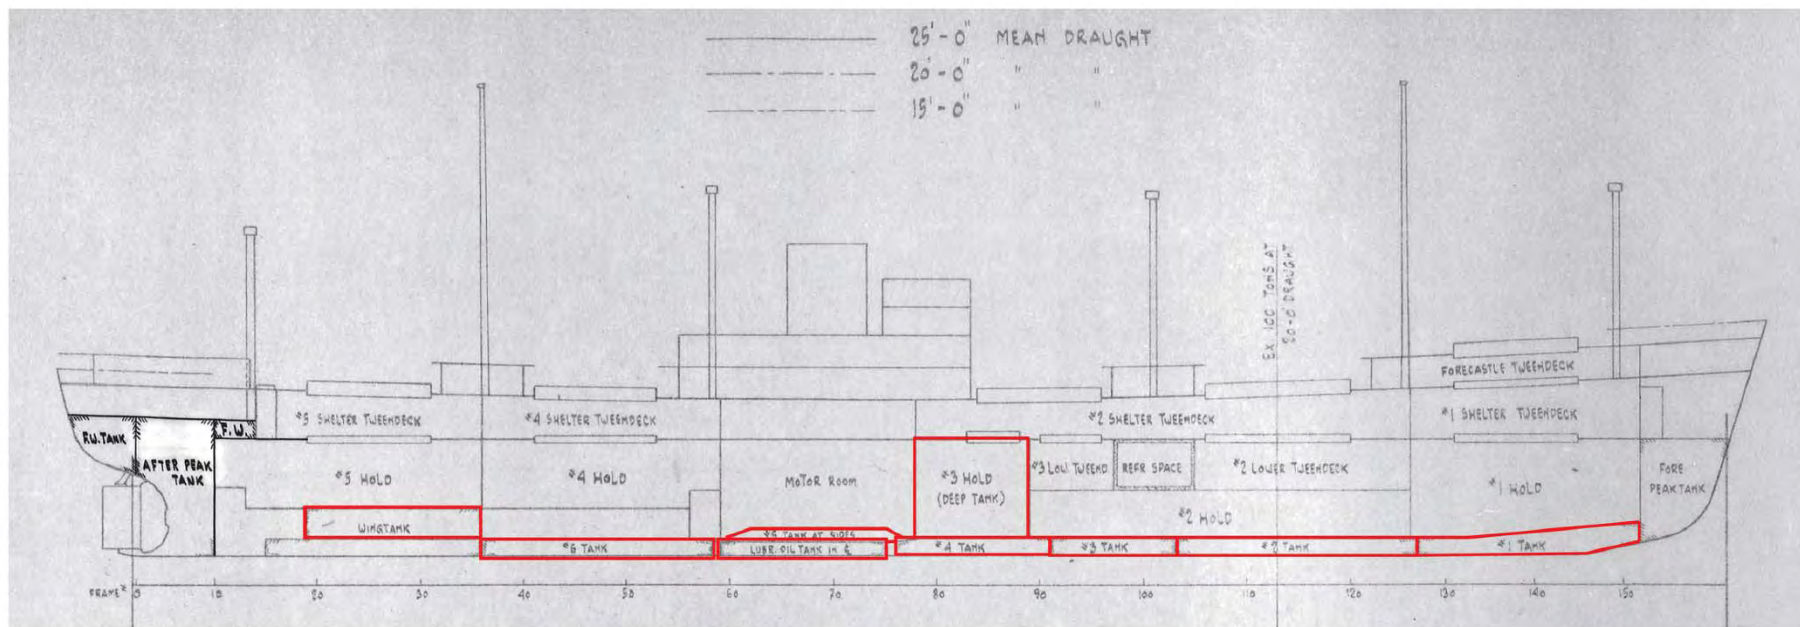
Deep Tanks Designated to Carry Bunker Fuel & Lube Oil

Fernstream as designed had nine designated sections between frames with multiple deep tanks that could be utilized to carry bunker fuel as noted in Figures 1-3. The total capacity of these tanks totaled 2,615.6 Oil Tons @ 38 C.F.; 18,925 NUCOS Volume (bbls) and 794,829 NUCOS Volume (gals) with the assumption that oil tones equals metric tons (tonnes) of Diesel, as noted in Figure 1. (Stout 2013). No records or interviews with crewmen of *Fernstream* at the time of loss have determined which deep tanks carried bunker fuel or other lubricants. This volume is higher than the previous assessment.

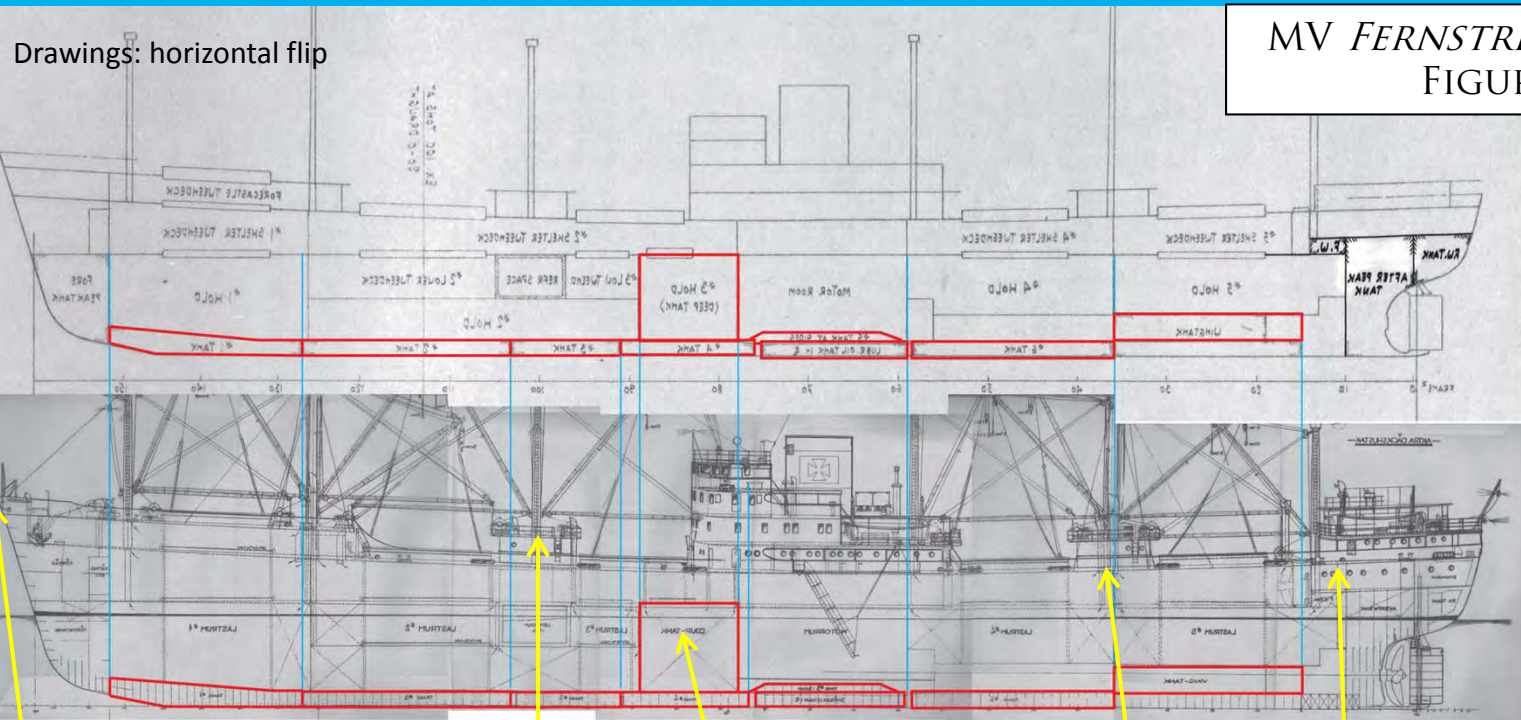
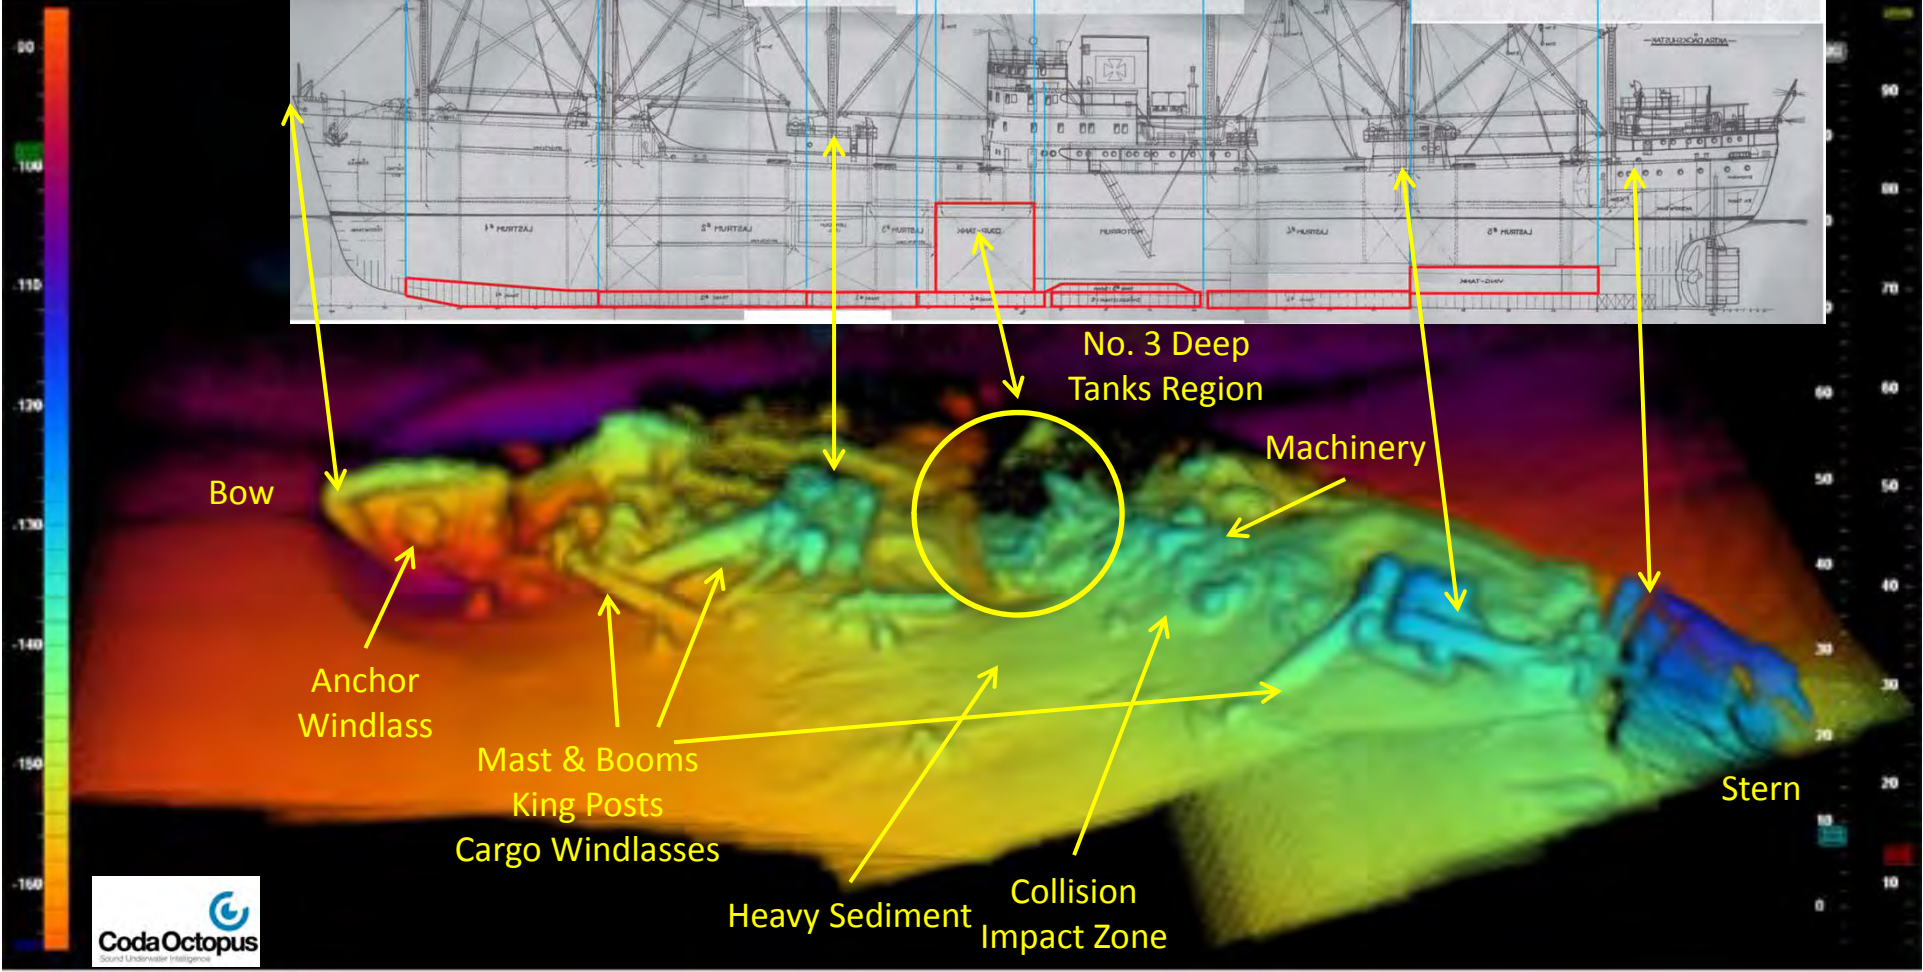
MV *FERNSTREAM*
FIGURE 5

The shipwreck of *Fernstream* as observed from the multi-beam and side-scan sonar data recorded in 2013, Figures 5-6, confirms that the shipwreck sits upright with the forecastle, partial remains of the stern-house and bridge-house, as well as the forward and after mast house structures all visible (Coda Octopus 2013). Figures 4-13 indicate that the hull has suffered from catastrophic collapse of the bridge-house structure, has a severe breach in the steel hull on the starboard side forward of the bridge-house, masts and booms, king posts have all collapsed onto the main deck or possibly shelter deck, and the port side of the wreck is buried deep in sediment. The stern is the highest remaining structure above seafloor, but also in a state of collapse. The shipwreck appears to be listing to port in the bow. At the starboard breach in the hull forward of the bridge-house structure, the bow is no longer in longitudinal alignment with the after part of the hull to the stern. (NOAA 2013). Outside the wreck, the starboard side of the hull shows evidence of scouring of sediment, more prominently in the bow, a typical occurrence with shipwrecks and due to their position on the seafloor in prevailing currents.

On the starboard side of the shipwreck where the No. 3 deep tank(s) are located, the sonar imagery (Figures 5-6) reveals a severe breach in the hull. Although not related to the collision impact zone, a catastrophic event has caused a major break in the hull, possibly when the freighter impacted the seafloor, was weakened by the collision, or 61 years of degradation of a steel-hull vessel in a saltwater environment caused the hull to collapse on itself. There is a high probability the No. 3 deep tank(s) has also succumbed to the elements or has been impacted by the collapse of the bridge-house structure.
